Confidential Inspection Report
2521 5th Drive
Florence, SC

CLIENT & SITE INFORMATION: / ROWELL'S HOME INSPECTIONS LLC

1.1 REPORT/ FILE #: 61109.	1.2 DATE OF INSPECTION: June, 11, 2009.	1.3 TIME OF INSPECTION: 1:30 PM.
1.4 PROPERTY OPEN BY: Home Owner.	1.5 CLIENT NAME: >cY7i gltca Yf.	1.6 CLIENT'S REALTOR / AGENCY >cYFYUtr.
1.7 INSPECTION SITE: 2521 5 th Avenue Drive.	1.8 INSPECTION SITE CITY/STATE/ZIP: Florence, SC.

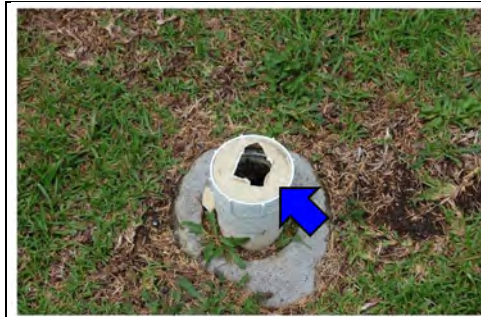
Sewage clean out cap missing / damaged @ Left front lot line -
The home owner is in most cases responsible for the sewage line maintenance from the house to the sewage tap. This tap is usually located near the street.

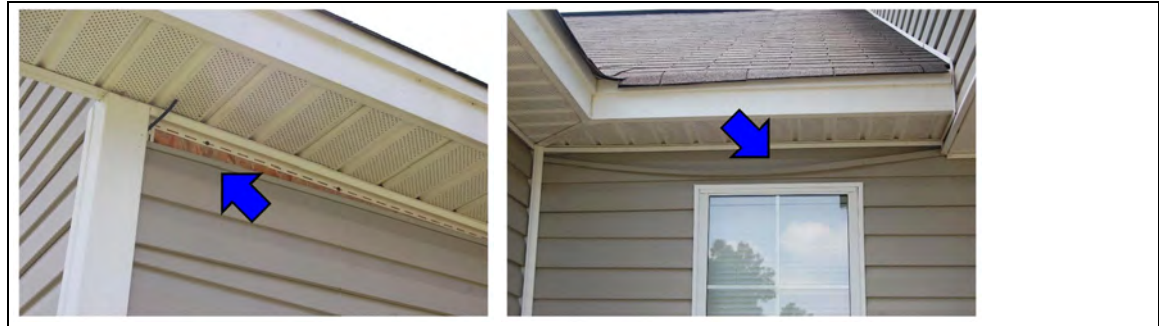
Loose unsecured vinyl siding noted in areas around the structure @ Right front side of house. Also there is a loose piece of vinyl J trim adjacent to the front porch -
Recommend a contractor evaluate all vinyl siding areas / repair - secure as needed.

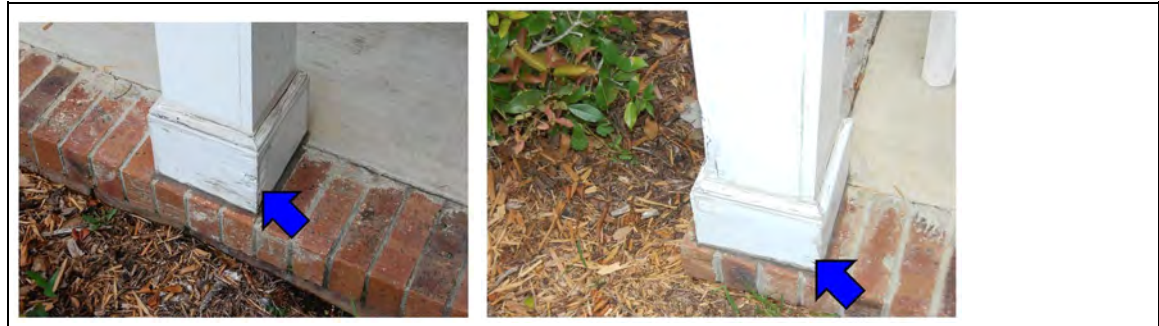
FRONT ENTRANCE
Front porch support columns have some softness and deterioration noted to the bottom areas .
Recommend a contractor evaluate / repair as needed.

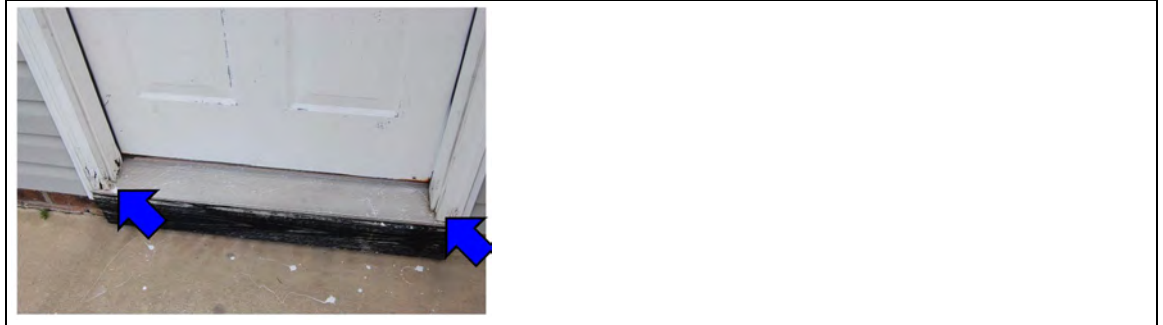
REAR ENTRANCE -
REAR ENTRANCE - Some softness and deterioration noted to the bottom portions of door unit -brick mold / side jambs .
Recommend a contractor evaluate and repair as needed.

Cosmetic staining noted to interior flooring.

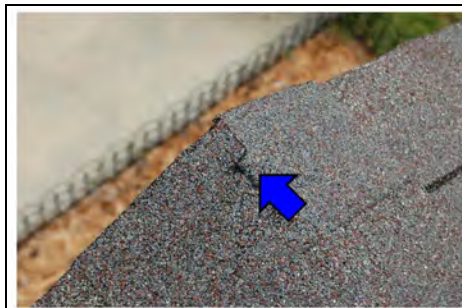
The center metal ridge line vents are loose in areas. Also some portions are somewhat crushed / flattened -
There are some vent pipe boots that are not fully sealed to prevent water intrusion -
Slightly raised nails under some shingles -
Some valley shingles may not be fully platted. Shingles slightly turned up in valleys -
Left front end has a damaged end cap shingle -
Recommend contractor evaluate roof with a emphasis on these areas.
Note - Repairs noted at left front gable edges -
