Confidential Inspection Report
4412 Somewhere Lane
Hometown , SC

Rowell's Home Inspections
P.O. Box 12579
Florence, SC 29504
SC HOME INSPECTORS LICENSE # 1768
SC RESIDENTIAL BUILDERS LICENSE # 7148

CLIENT & SITE INFORMATION: / ROWELL'S HOME INSPECTIONS LLC

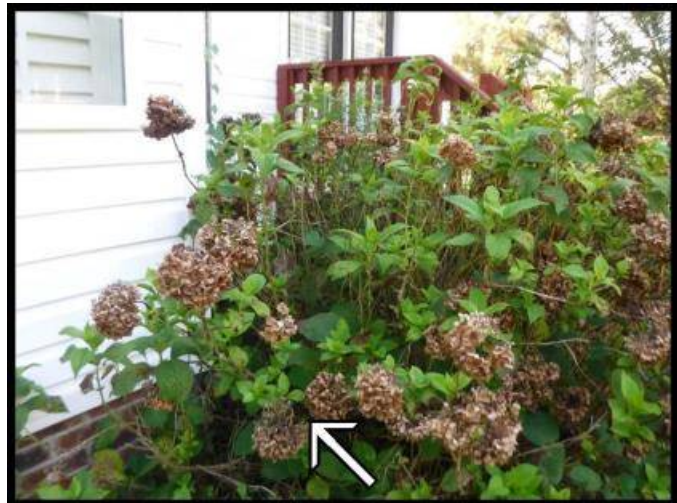
2.14 *Condition :*

- Plants and shrubs should be trimmed back 1 ft. from structure. This will help support ventilation through the crawl space and also may help maintain favorable conditions for exterior siding

Concrete Driveway -- The driveway has some typical cracking noted due possibly due to age - Recommend monitor- keep all areas tightly sealed / repaired.

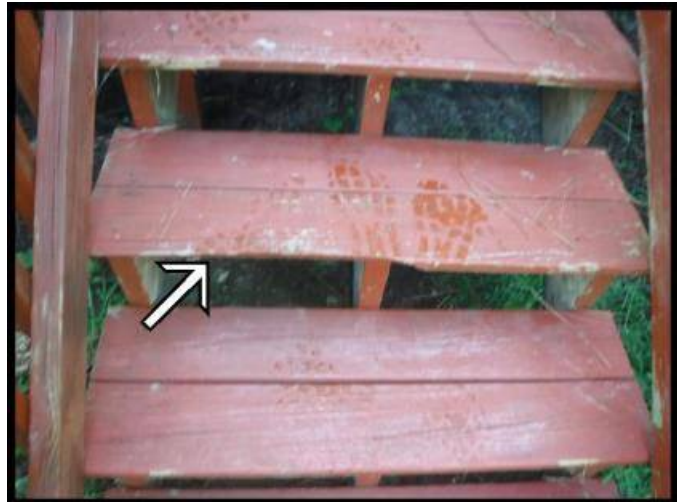
2.23 Rear / Side Entrance:

- **The rear entrance wood steps have a damaged step tread** - Possible trip / fall hazard

Recommend a contractor evaluate deck members - repair as needed.

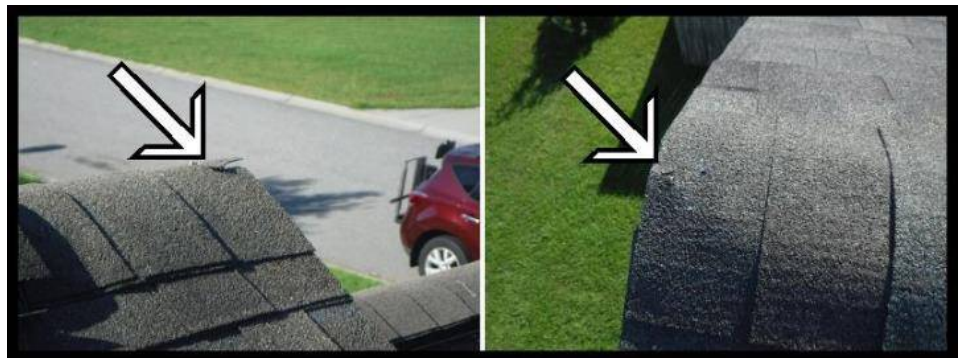
3.4 Roof / Conditions:

- **There are damaged end cap shingles at gable ends There are some nail heads visible from the roof that are not sealed @**
- Recommend a contractor evaluate / seal as needed. --
Recommend a roofing contractor evaluate - repair as needed.

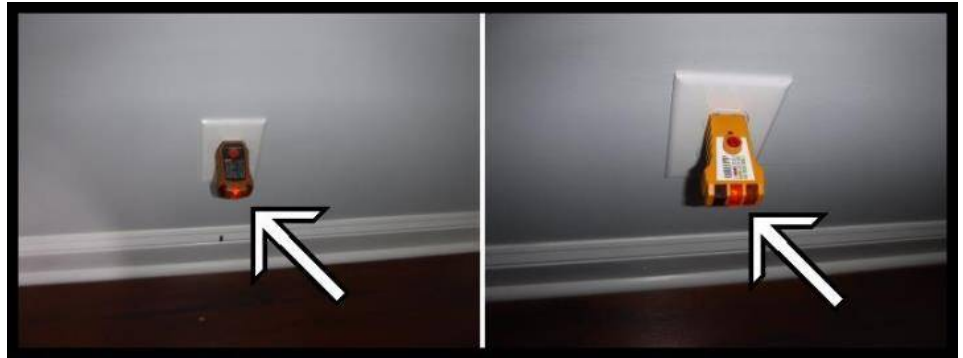
5.2 Switches / Outlets / Wiring / Conditions

- **There are Outlet[s] with a open grounds as indicated with test meter in the left side upstairs bedroom .**
Recommend a electrician / contractor evaluate interior outlets - repair as needed.

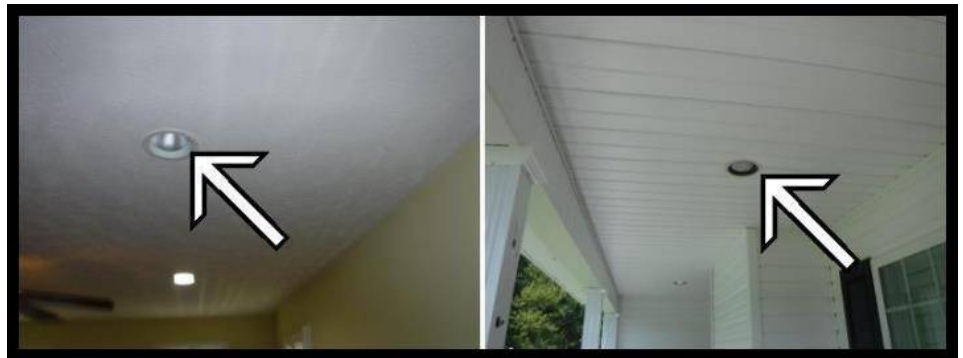
5.3 Exterior Lights - Fans / switches

- Some scattered exterior and interior lights did not work - Possible bulb outages
Recommend evaluation of all lights , repair / replace bulbs as needed.

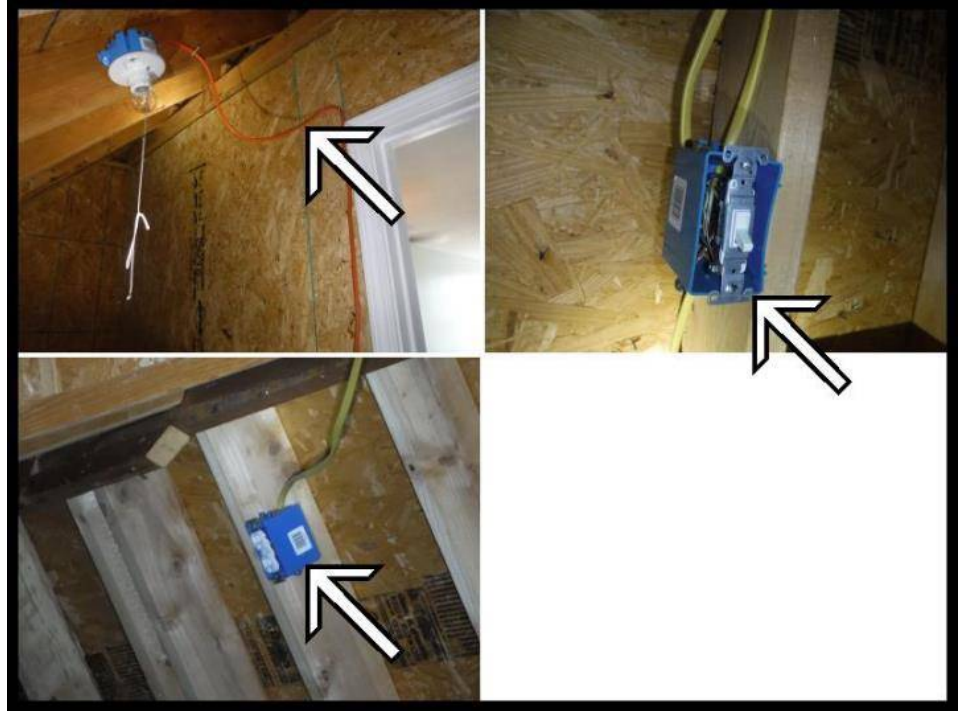
5.4 Electrical attic

- **There is extension cord type wiring connected a attic ceiling light.**
Note - Extension cord type wiring should be used for temporary applications only.

- There are outlets and switch boxes in the attic with no covers installed.
Recommend a electrician contractor evaluate - repair as needed.

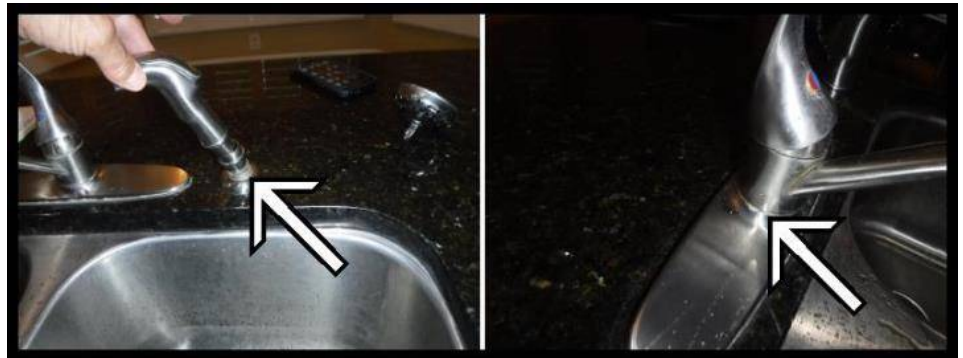
6.1 Sink / Faucet / Supply & drain lines

- **Slight leak at the kitchen faucet valve area- This is a slight leak when water is used or faucet turned - In most cases gasket repairs will correct this leak -**
- **- The kitchen sink spray is not secured to the counter top**

Recommend evaluate - repair as needed.

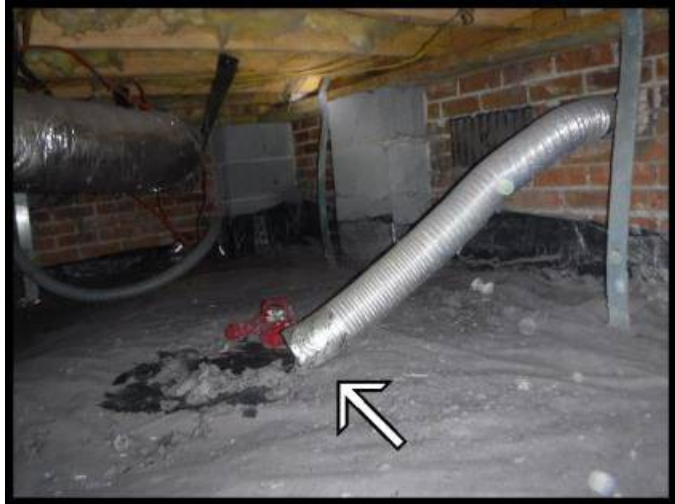
6.10 Conditions

- **The Dryer vent hose in the crawl space is damaged / disconnected** - [Right rear crawl space area]
· *Recommend a contractor evaluate dryer vent piping / repair as needed.*

Note -
*Newer Recommendations for dryer ducts are -
Exhaust ducts shall be constructed of minimum 0.016-inch-thick (0.4 mm) rigid metal ducts, having smooth interior surfaces, with joints running in the direction of air flow. Exhaust ducts shall not be connected with sheet-metal screws or fastening means which extend into the duct.. Ducts should be supported every 12 ft. Exhaust duct terminations shall be equipped with a back draft damper [cover] and extend to the exterior -*

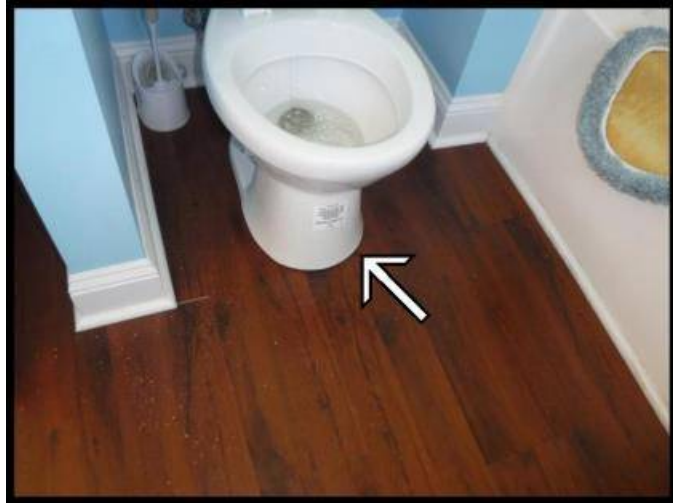
7.3 Toilets:

- **- The toilet bowl is loose at the flooring at right side down stairs bathroom**

Note / Continual uncorrected toilet movement may cause damage to the wax seal and result in a under floor leak

- Recommend a plumber / contractor evaluate / repair - secure as needed.

- *Note - Most contractors shim and or seal around the toilet bases to help with unwanted movement. When sealing toilet bases some contractors leave a small unsealed area at the rear of toilet to identify any possible toilet drain [wax ring seal] failures.*

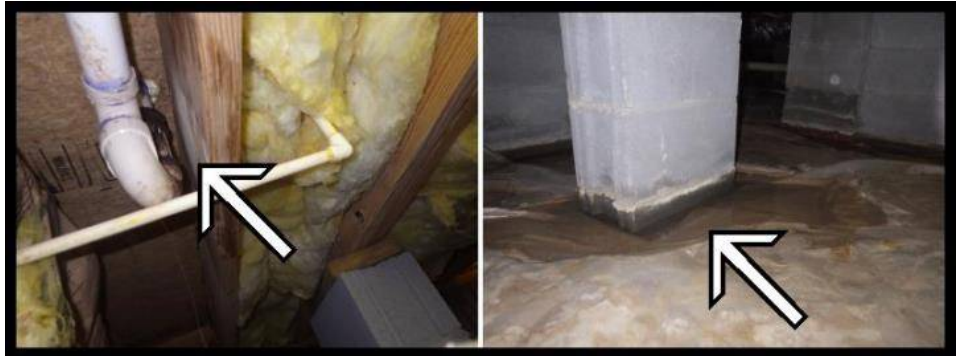
- 10.1 Water supply lines Plastic - PVC / CPVC.
- 10.2 Drain lines / Crawlspace Plastic - PVC.
- 10.3 Plumbing conditions :

- There is a substantial leak which appears to be a drain line connection under the left rear tub / shower area with standing water on the vapor barrier
Recommend a contractor / plumber evaluate under leakage etc. - repair as needed.

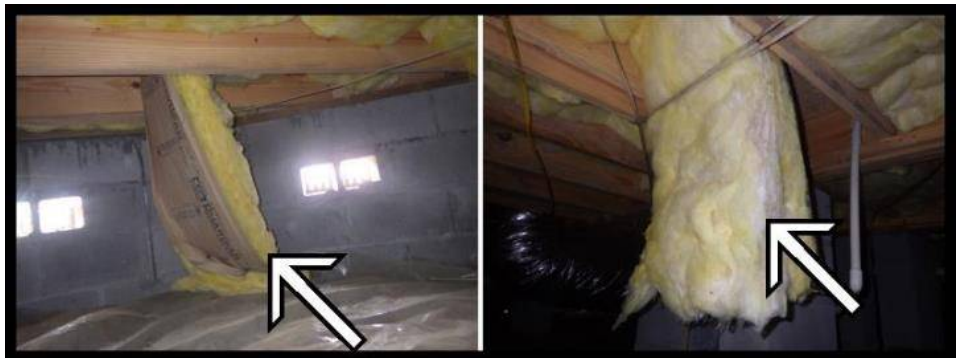
11.5 Insulation condition :

- **Insulation in the crawl space is missing / fallen and or unsecured in scattered areas.**

Recommend a contractor evaluate / repair - re-secure as needed.

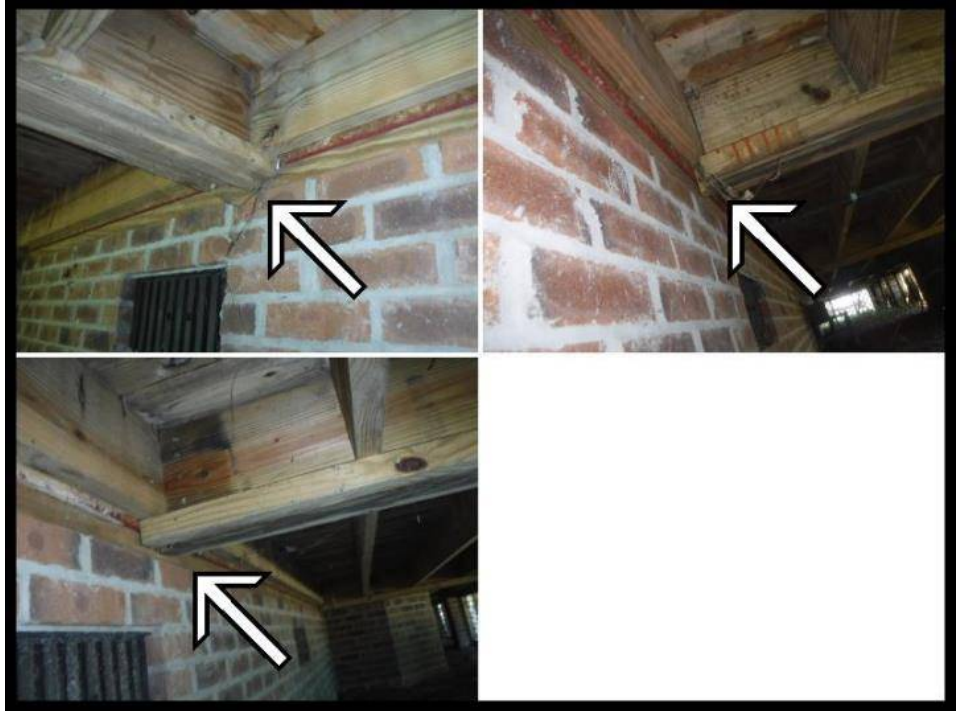
11.9 Floor Joists / Sub-flooring/
Sills - Conditions:

- Masonry support piers or double joist hangers or ledgers etc. are not positioned under the framing double sills under the front and rear porch areas [Sills connections adjacent to the house]
These double sills usually support multiple floor joists -

Recommend a qualified contractor evaluate and repair as needed.

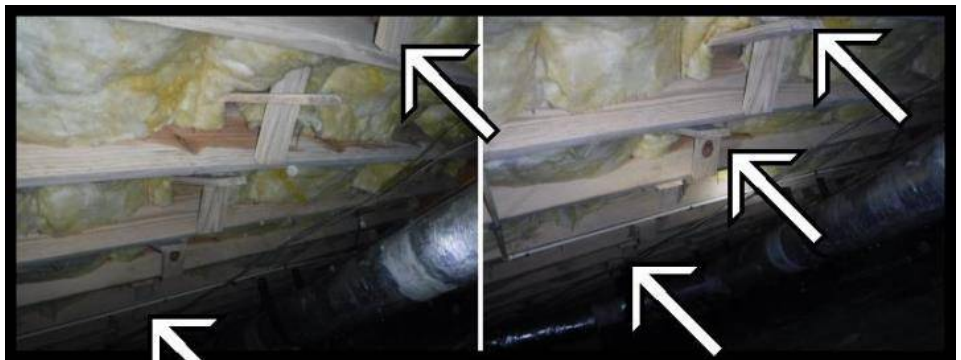
11.11 Crawl space observations /

- X bracing in the crawl space was never nailed at bottoms
- Nailing of X braces may not be necessary for structural soundness, however nailing these braces will help with additional floor soundness.
- These braces are installed to help with under floor squeaks and help eliminate floor joist flex.

Recommend a contractor evaluate - Nail / secure as needed.
